## Golden State Mold Inspections

ID: Partial Inspection  
1117 Pacific Ave. #3  
Manhattan Beach, CA 90266

## Interior

## Kitchen

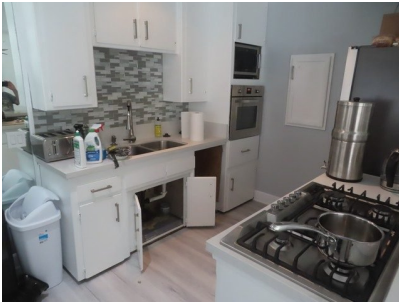
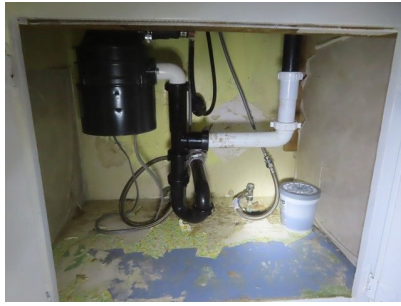
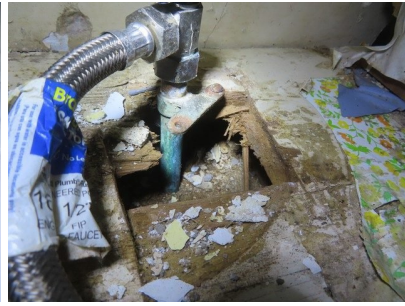
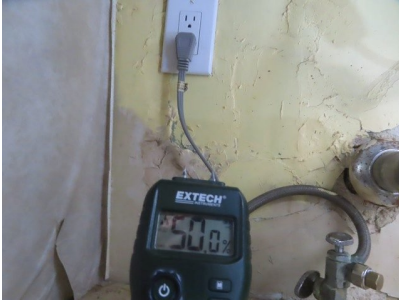
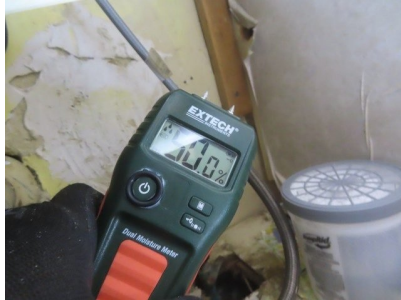
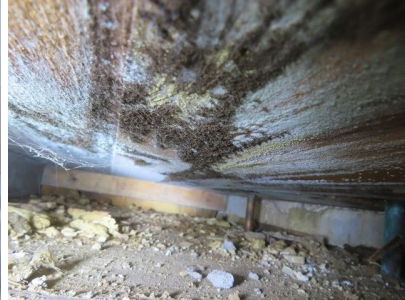
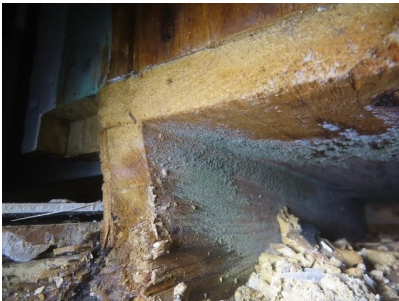
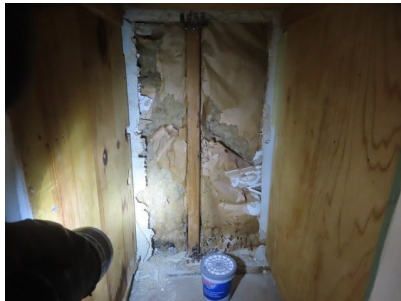
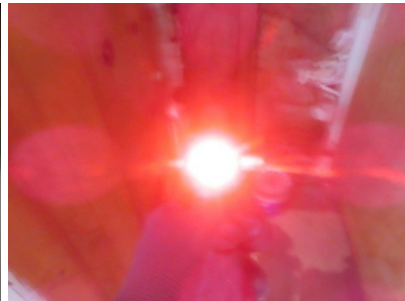
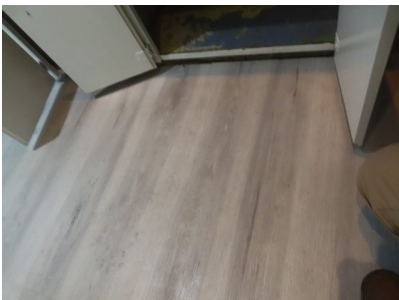
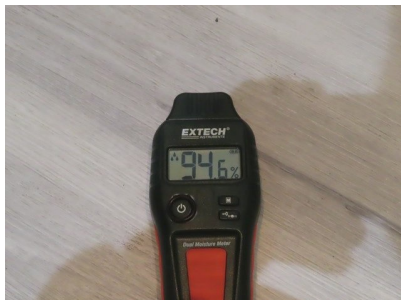
There are signs of microbial growth, water damage and high moisture test readings at the sink cabinet.

High moisture test readings extend to the adjacent dishwasher cavity and to the floor covering in front of the sink cabinet.

A mold swab sample was taken, see section on Microbial Samples.

1. Isolate the area and create a negative air environment.
2. Remove cabinetry, wall covering and floor covering to a minimum of 14" beyond any mold growth, water damage and high moisture test readings.
3. Remove any water damaged building materials.
4. Clean surfaces per U.S. EPA guidelines, which are available at [www.epa.gov/iaq/molds](http://www.epa.gov/iaq/molds). It is recommended this cleaning be done with an approved microbial inhibitor in all areas mold like substances are present, such as 10%-25% bleach to water solution or other approved biocide.
5. Allow the area to dry out thoroughly. Use of high powered fans and dehumidifiers may be necessary.
6. Sand wood surfaces as necessary.
7. Run HEPA filter air scrubbers for 48 hours.
8. Obtain mold clearance before removing the containment and replacing materials.
9. Ensure the source of water intrusion is properly repaired.

**Note:** Further inspection may be necessary once materials are removed.
